**An Investigation of Glacial Outburst Floods from
Abyss Lake, Glacier Bay National Park, Alaska**

Technical Report NPS/NRWRD/NRTR-2003/312

**J. Scott Grover
Hydrologist**

June 2003

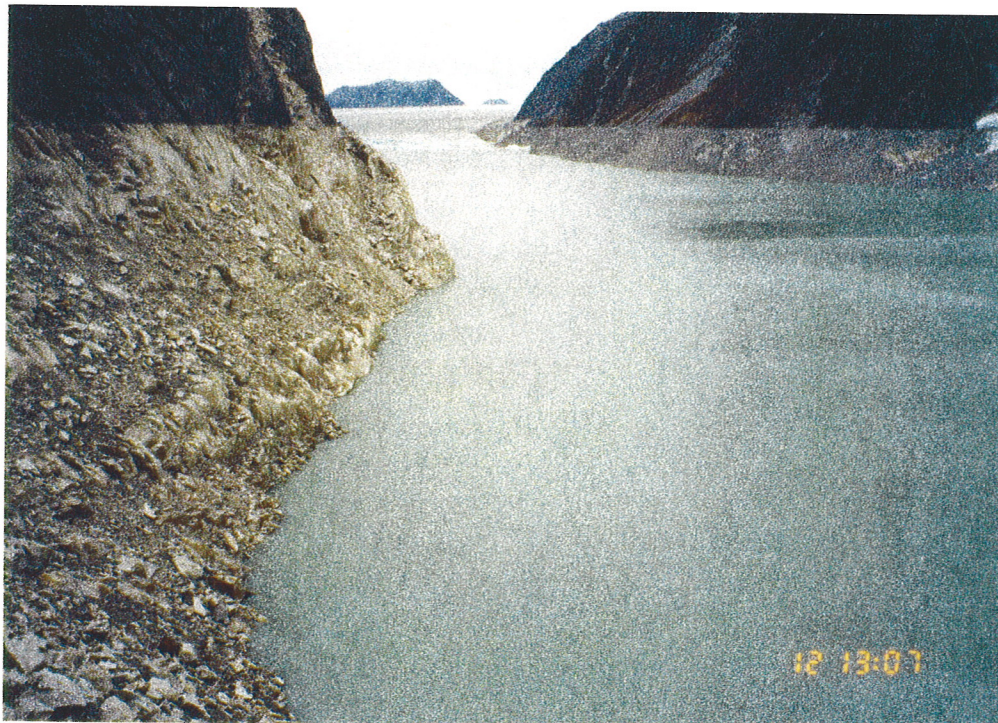
Photograph 2: View of Abyss lake taken from Dundas River outfall, and looking towards Brady Glacier and ice dam. Photo taken in October 1997, about two months after the large outburst flood. Note the stranded ice burg at the right edge of the photo. Distance from the all-time high water line to water surface measured as 87 m (285 ft). Water level drop resulting from the 1997 outburst flood measured as 77m (250 ft). Distance to ice dam is about 3.25 km (2 mi). Photo by Scott Grover.

Abyss Lake is located in the southwest region of GLBA (Photographs 1 and 2). Actual lake depth is estimated at 200-300 m—based on the slope of adjacent valley walls and assuming the bottom of the valley has the typical u-shape of a glaciated valley.

Data from the 1997 investigation shows that the outburst flood caused the lake level to drop 77 m (250 ft). Distances were measured from the debris/strand line to the existing water surface. This flood released approximately 130,000,000 m³ of water

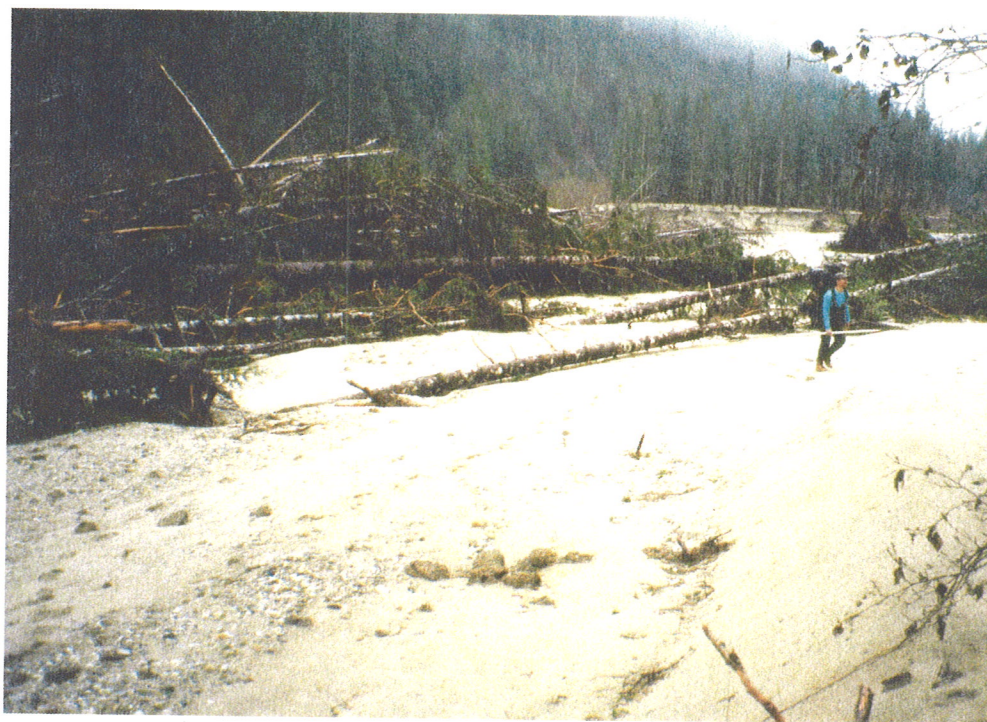
Photograph 5: GLBA biologist Chad Soiseth walks on newly formed point bar on right bank of the West Branch Oscar River. Bar is comprised of sand and cobbles. Large log jam of mature trees visible on left side of photo. Photo taken several weeks after the 1997 outburst flood. River visible in background. Photo by Scott Grover.

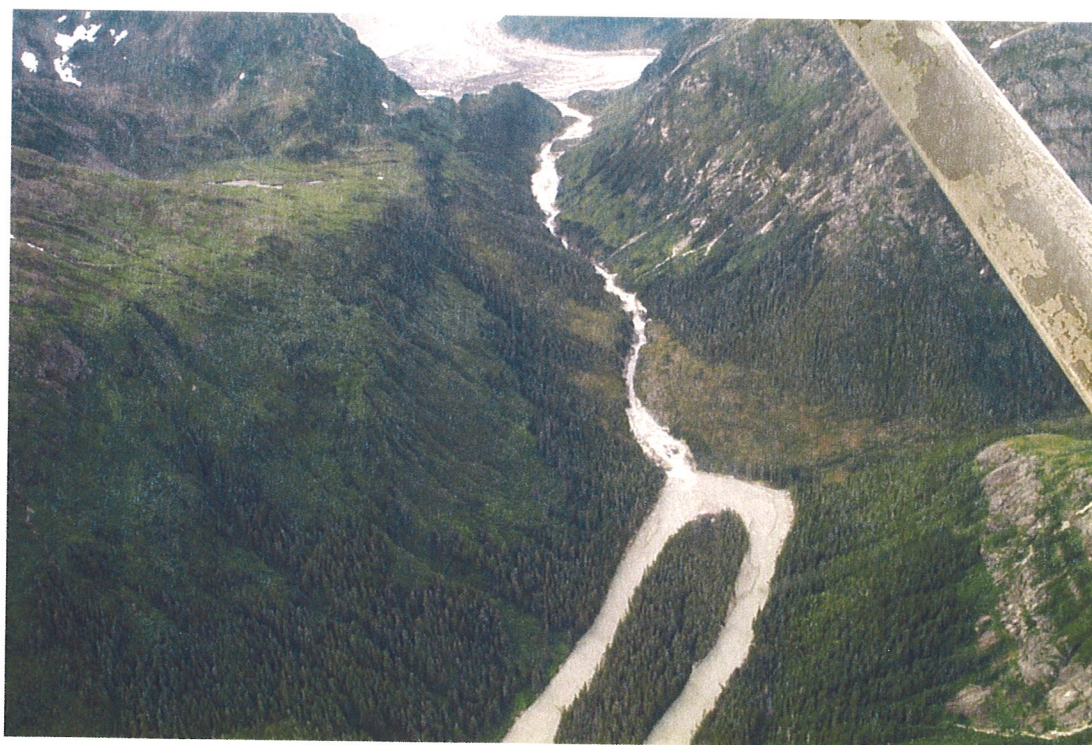
Photograph 6: Oblique aerial view of West Branch Dundas River. View is upstream. Brady ice field visible at top of photo. Dundas Falls visible just above point of river split. Photo taken August 23, 2001, during period of relatively high flow. Channel on left of photo was reclaimed by the 1997 outburst flood. Both channels are flowing bankfull in this photo. Aircraft wing strut visible in upper right. Photo by Rusty Yerxa.

Most of the trees displaced during the 1997 event were washed out of a thick forest which covered a large, mid-channel bar or island located just below the falls (Map 2, Photograph 6). Cores of the trunks of these trees were collected during the 1997 survey. Their analysis indicates that the trees were of a consistent age—about 80 years. Thus, this stand of trees was established around 1918. A true “return interval” for a flood events cannot be calculated without many years of peak flow data, but it can be concluded from the tree ring data that the 1997 event was probably the largest flow event since 1918.
